TOYOTA AVENSIS

ELECTRONIC PARKING BRAKE SYSTEM (EPB) FAILURES

SEALED BOX - WATER INGRESS

ANALYSIS OF WINTER EPB FAILURES

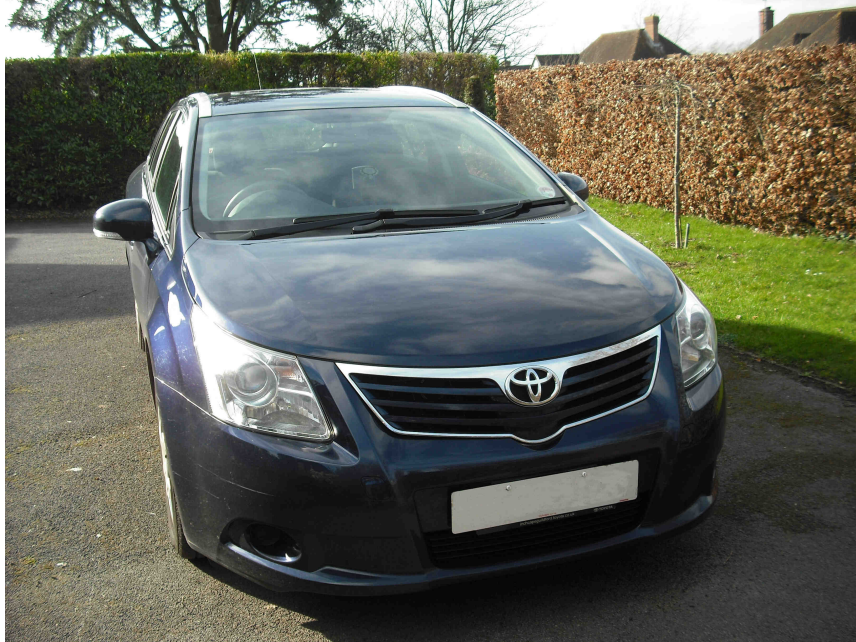
Toyota Avensis: two electric parking brake system failures in four years:

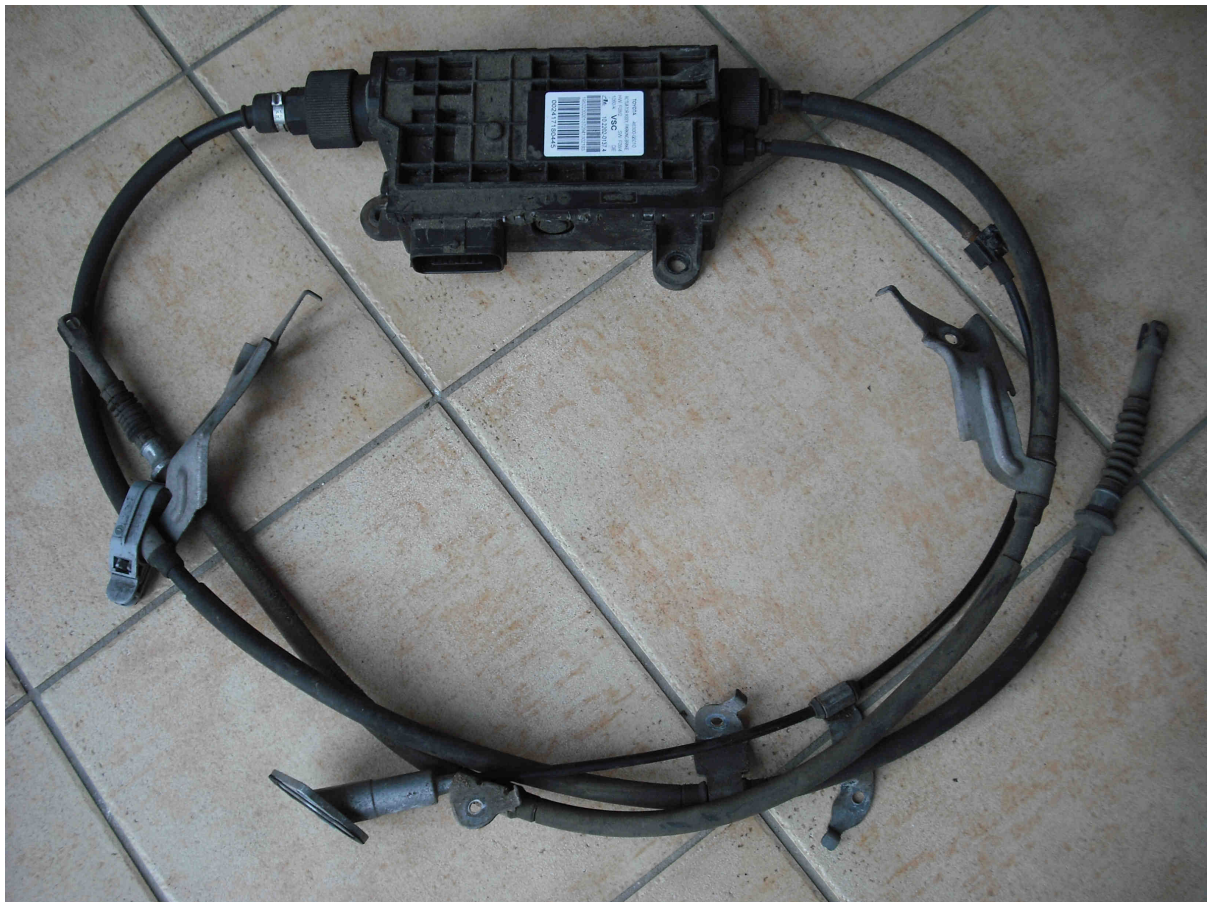
Faulty EPB removed:

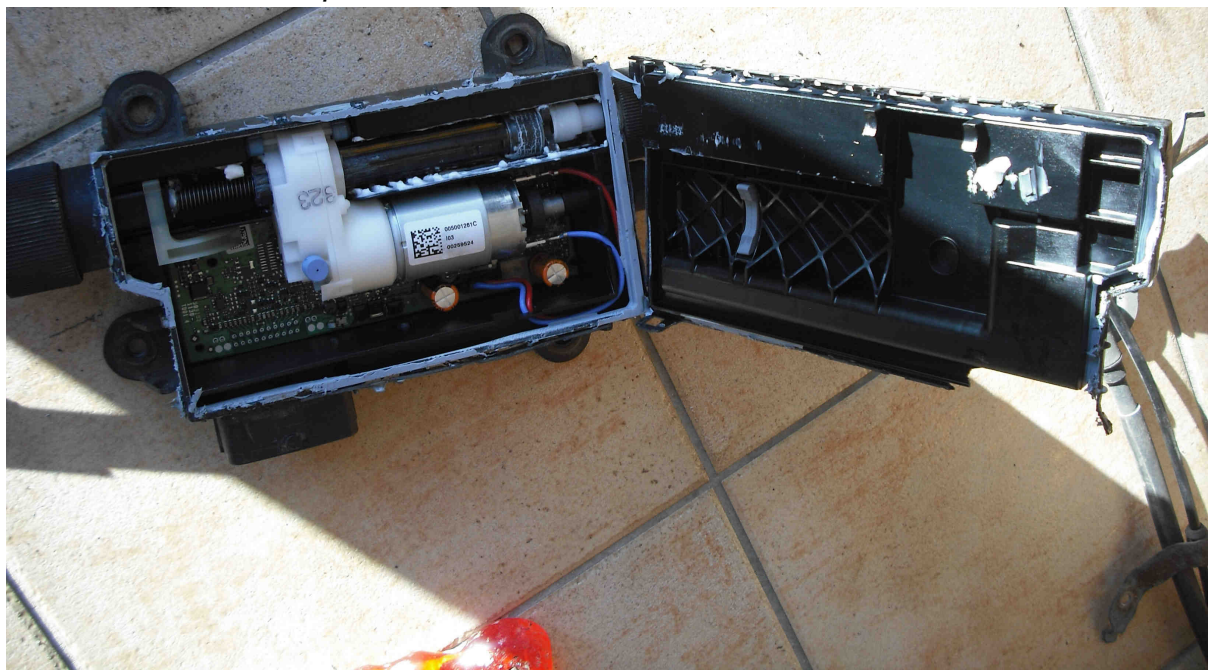
The box seal broken open:

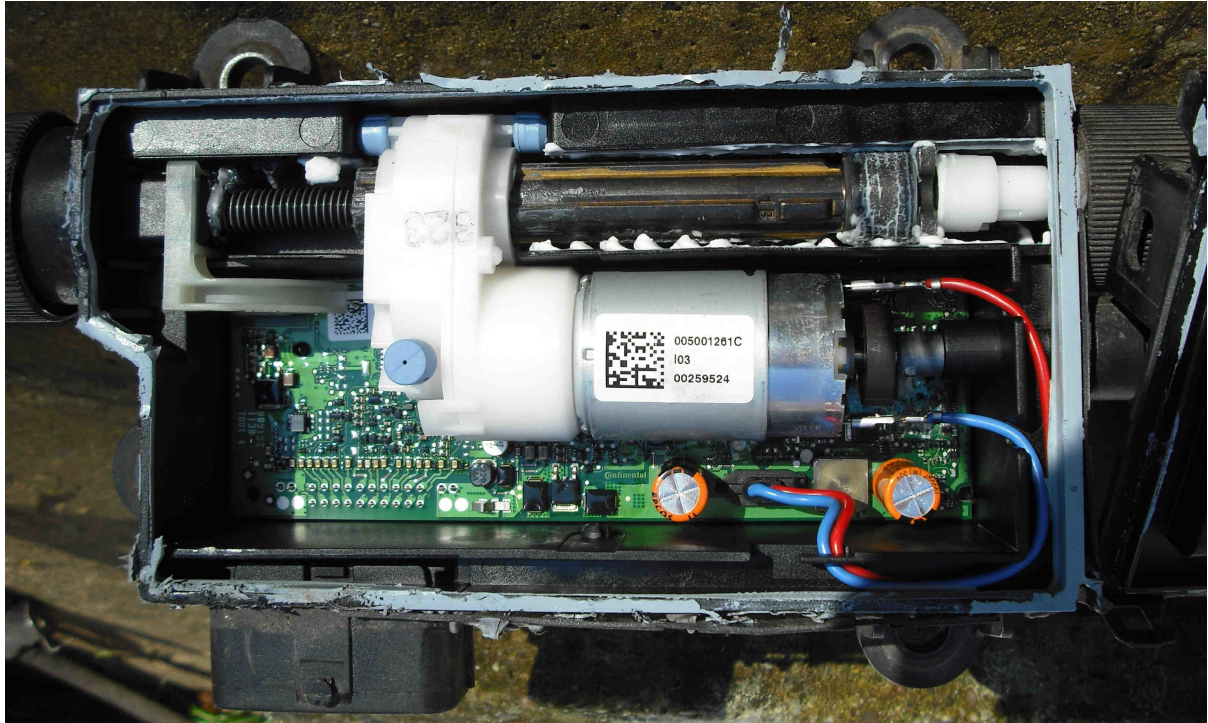
Circuit board inside with its 'Continental' logo:

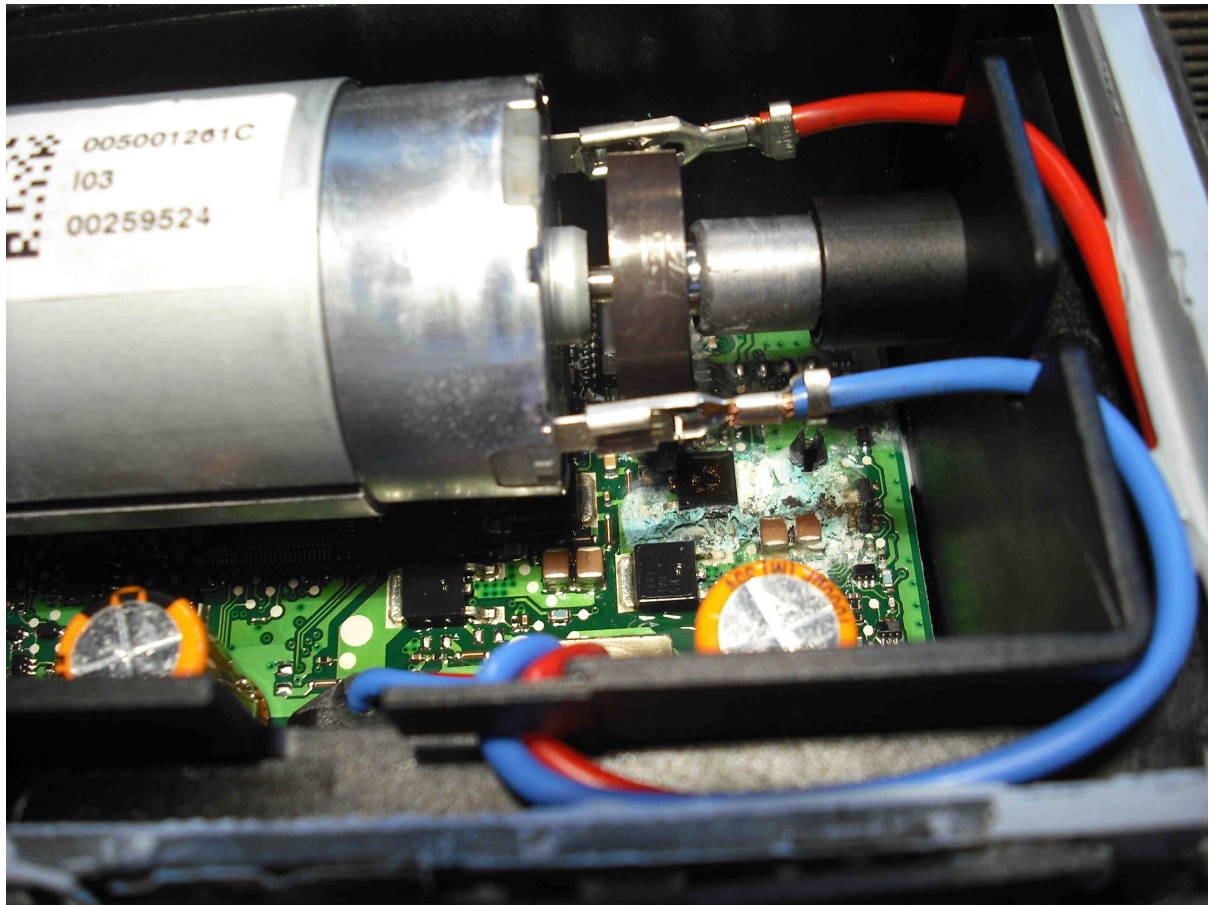
The most recently failed unit was dismantled and electrolytic corrosion found covering a 25mm patch of the circuit board.

The damage is caused by water. The location is at the rear of the motor and below the entry point of the parking brake release Bowden cable. From end to end the Bowden cable assembly is not airtight, as noted in the handbook on page 569.

Moisture in the air within the Bowden cable condenses and then drips into the EPB since the cable slopes downwards. In addition, air within the EPG box will expand when warm then contract when cold, thus creating a vacuum which sucks in water from the Bowden cable.

White corrosion salts on the circuit board below the manual parking brake release:

We design high reliability electronic systems. We neither supply nor repair automotive parts. Repair possibility: IF corrosion has not seriously damaged any circuit tracks or components then it might work after washing the board using a small paintbrush with PCB cleaner and then spraying with Electrolube contact cleaner oil to halt further corrosion. It is conceivable this could be achieved by 'keyhole surgery' through the Bowden cable hole.

- Toyota specify a hermetically sealed replacement Bowden cable assembly.
Update, April 2014: *"We are confident that the known moisture issue on the Avensis electronic parking brake system has been acknowledged and there has been a change in design of this part which has improved the seals. The design of the main box has also been improved."* – Toyota.
- Fit a threaded cap to seal the EPB's parking brake release hole properly, then cap and tie off the Bowden cable safely. Clearly, refitting would be required if manual parking brake release were ever needed.

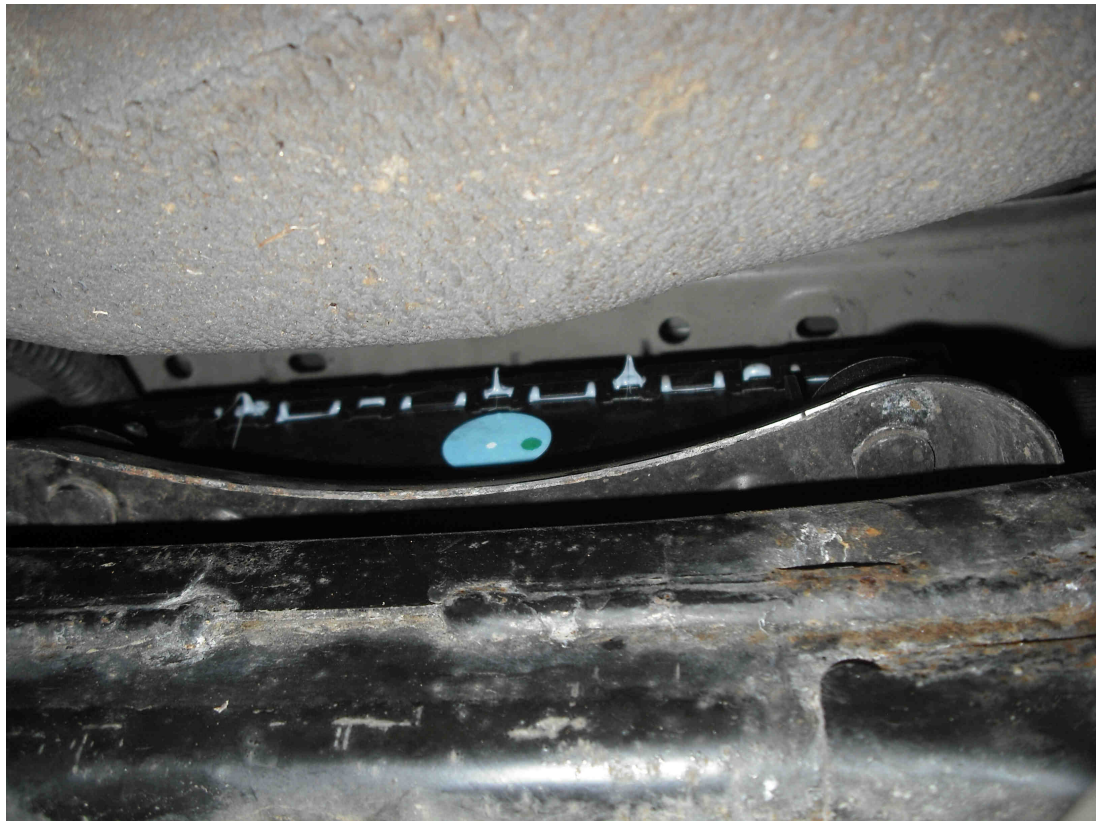
Electronic Parking Brake mounted above a strut between the rear wheels:

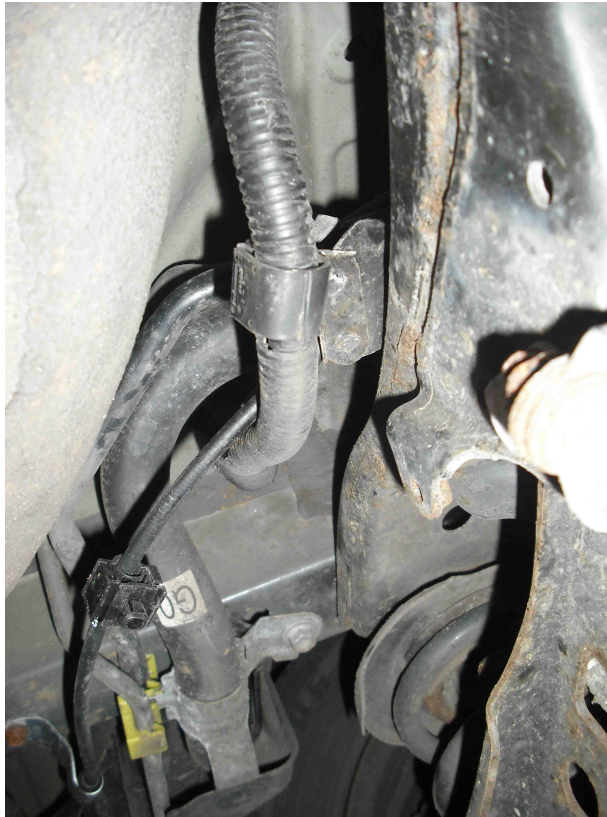
Manual parking brake release Bowden cable descending from the rear boot area:

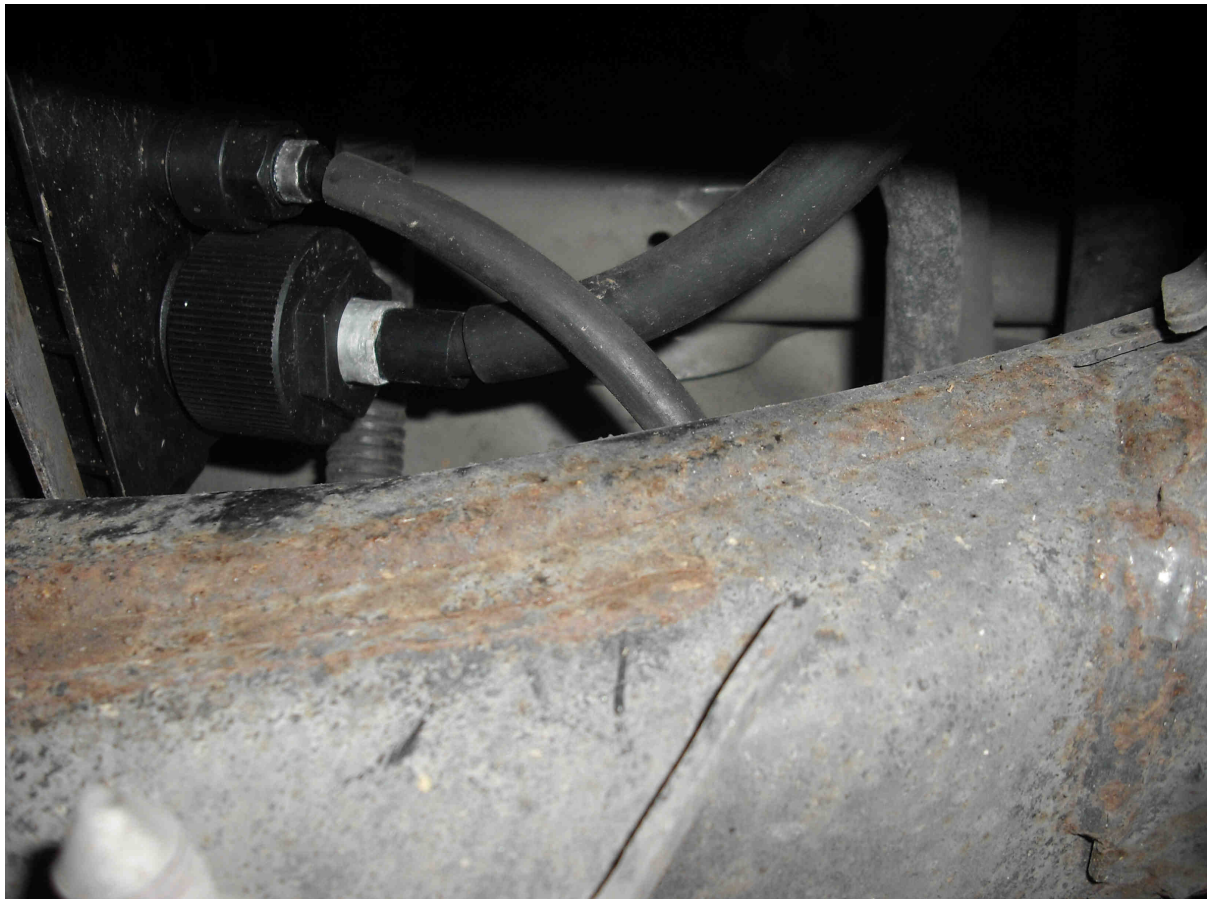
Parking brake release Bowden cable and a brake actuator connected to the EPB:

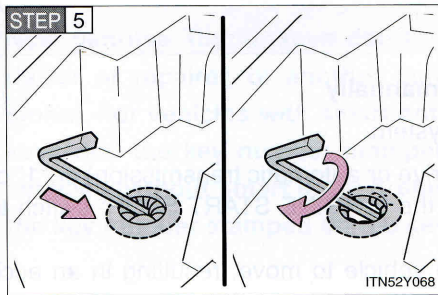
5-2. Steps to take in an emergency

The manual notes how a missing or damaged seal could allow standing water to flow into the parking brake release and consequently require EPB replacement:

If the trunk has flooded with water when the seal has been broken or is missing (for example, if the vehicle has been left outside in the rain with the trunk lid open or removed), the parking brake system will need to be replaced.

The seal needs to be replaced by any authorized Toyota dealer or repairer, or another duly qualified and equipped professional.
