TOYOTA AVENSIS

ELECTRONIC PARKING BRAKE SYSTEM (EPB) FAILURES

SEALED BOX - WATER INGRESS

ANALYSIS OF WINTER EPB FAILURES

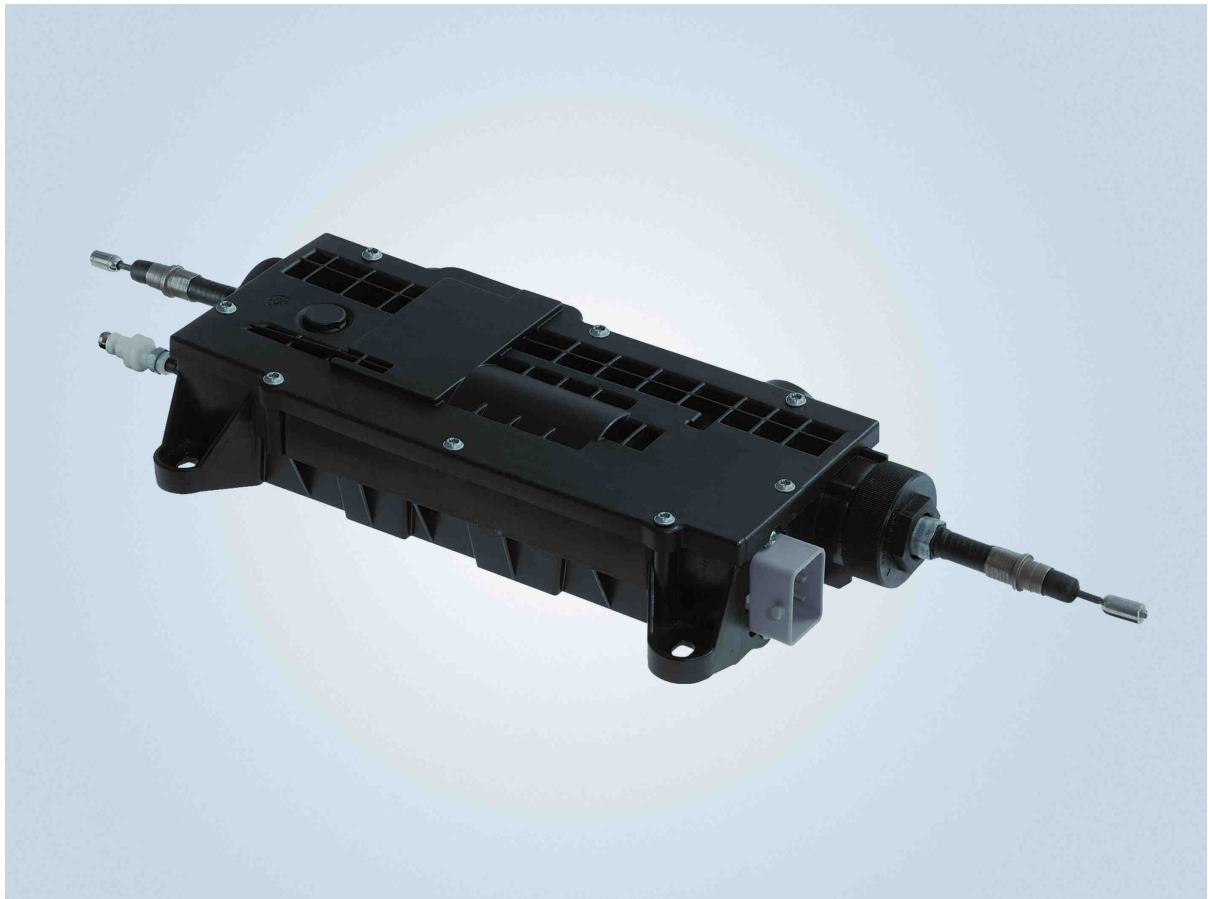
Variant of the Continental 129889_en:

The most recently failed unit was dismantled and electrolytic corrosion found covering a 25mm patch of the circuit board.

The damage is caused by water. The location is at the rear of the motor and below the entry point of the parking brake release Bowden cable. From end to end the Bowden cable assembly is not airtight, as noted in the handbook on page 569.
